## Case Study: Failure Analysis of Sulfuric Acid Supply Line

VGO Testing & Inspection Engineers was retained by an industrial client to determine the cause of failure of a 1-inch diameter carbon steel pipe used to convey 93% sulfuric acid to a demineralizer in the steam plant. The client reported that the line, which was thought to be several years old, failed by developing a hole at an elbow between the discharge pump at the acid supply tank and an automatic valve which controls the flow to the demineralizer. Several months earlier, the same line reportedly developed another leak, downstream of the current failure.

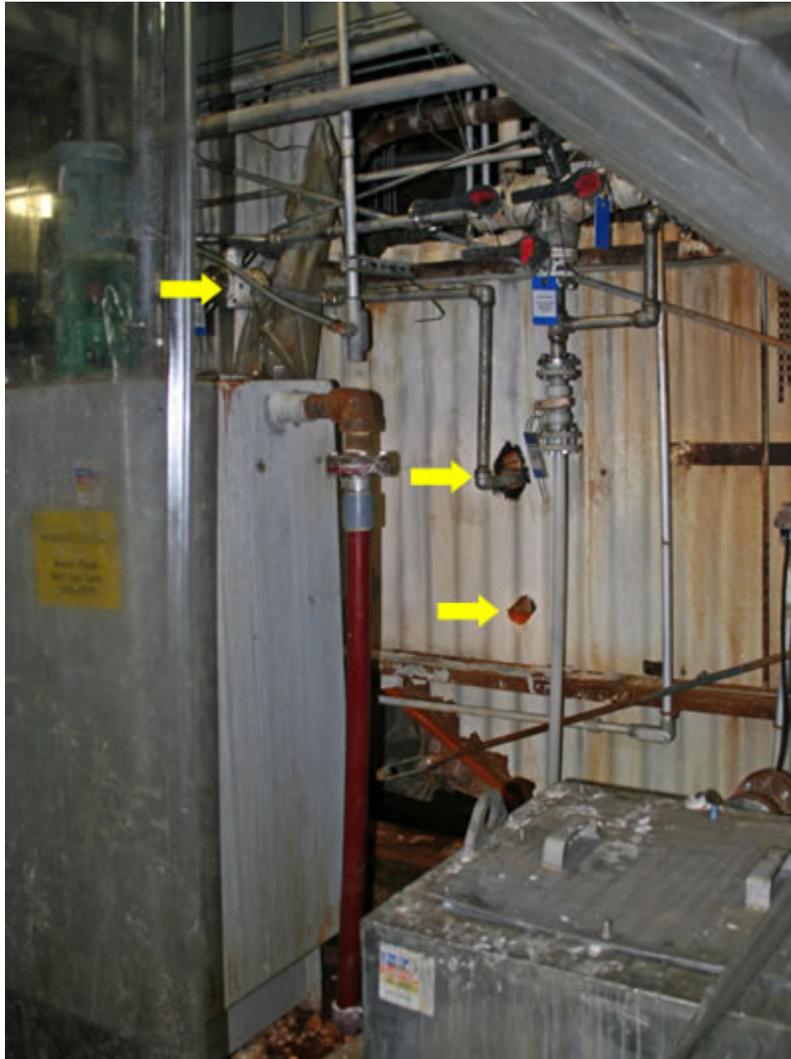
**Figure 1. Sulfuric acid tank and piping**

Figure 1 shows the 93% sulfuric acid storage tank (left, behind clear plastic screen) and the piping to the demineralizer after the failed pipe had been removed from service and replaced with new pipe. The new pipe, which was reportedly Type 316 stainless steel, was routed through the wall in back of the tank (middle arrow) approximately 18 inches above the location where the failed line had been routed (bottom arrow).

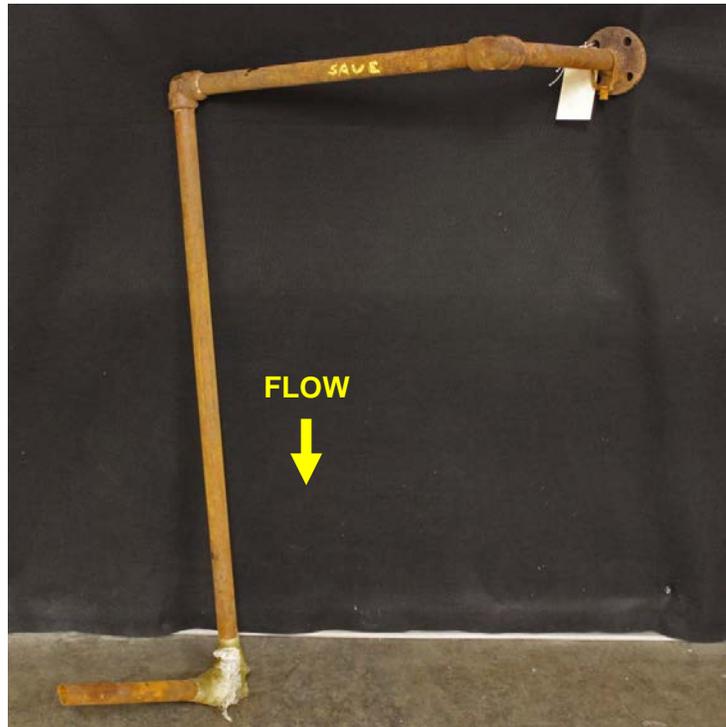
**Figure 2. Submitted section of sulfuric acid piping**

A section of the failed line, including the flange where it was attached to the outlet from the pump (top arrow, Figure 1), three elbows, and four sections of pipe, was submitted to VGO for analysis (Figure 2).

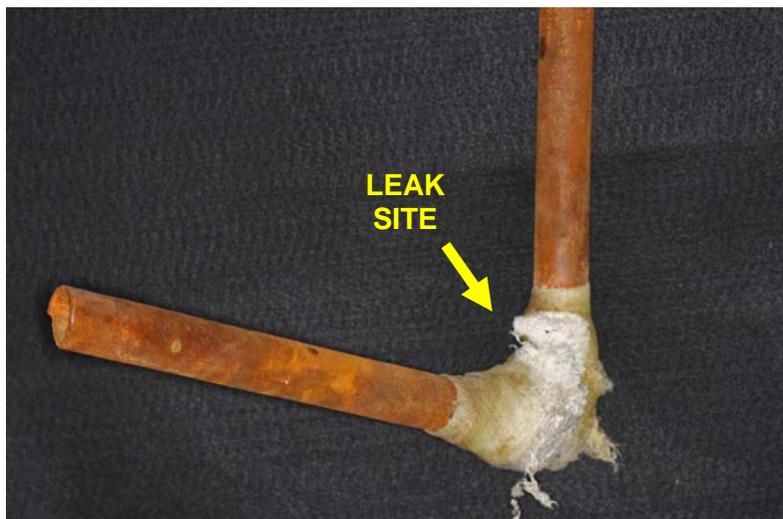
**Figure 3. Location of leak in failed section of piping, as-repaired in field**

VGO's client reported that when the leak was first discovered, temporary repairs were made by wrapping the leak site with fiberglass tape, coated with polyurethane resin. The repair soon failed, and the leaking section, from the flange at the pump outlet to an unreported location downstream of the leak, was removed from service and replaced, reportedly with Type 316 stainless pipe.

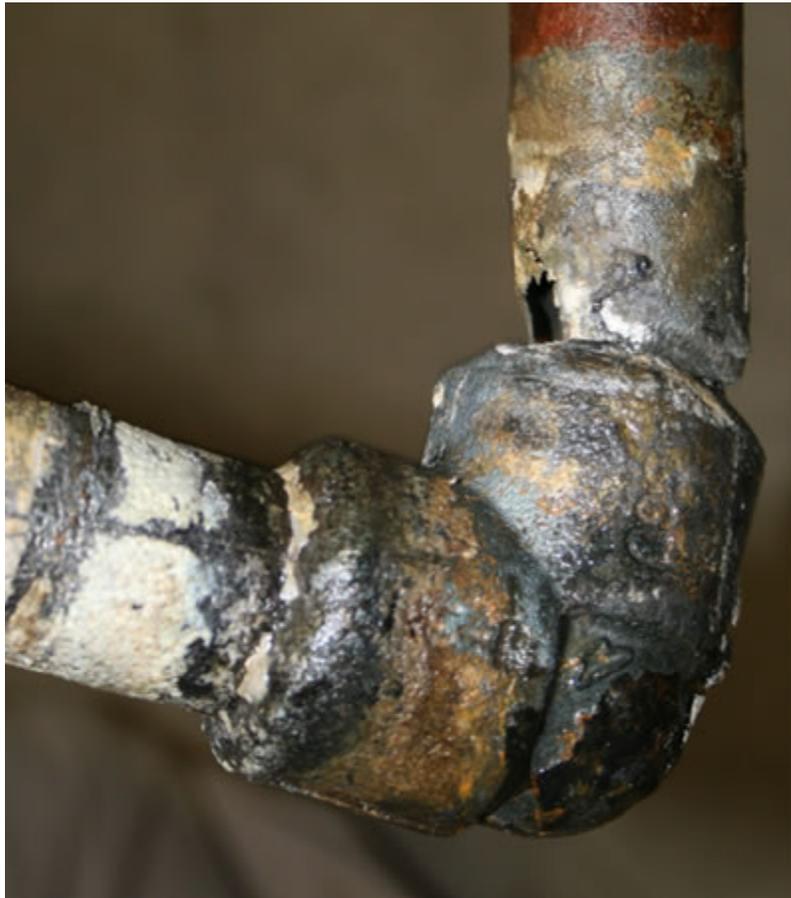
**Figure 4. Leak site after removing fiberglass patch**

Upon removing the fiberglass patch and wire brushing the line to remove the less adherent surface deposits, the leak—which was about ¼ inch in diameter—was readily apparent in the pipe wall, just above the elbow (Figures 4 and 5). The pipe wall surrounding the leak was only a few thousandths of an inch thick—so thin that the pipe had buckled, probably when the section of line was being removed from service.

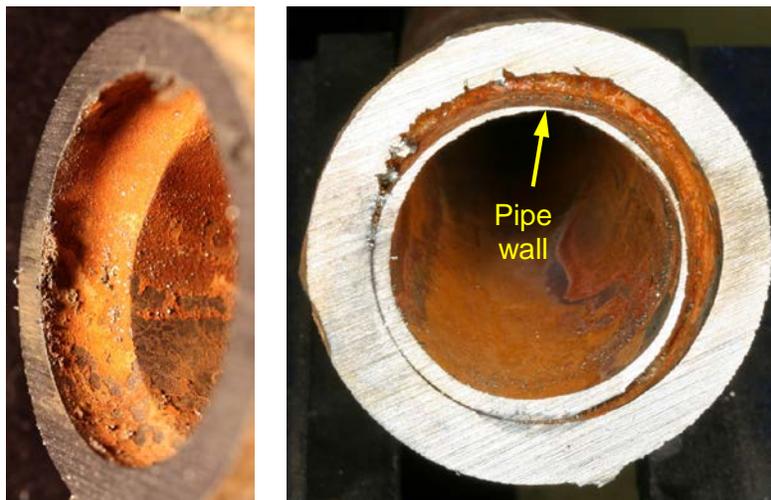
**Figure 6. Transverse section thru pipe and elbow at elbow outlet**

The elbow material was considerably thicker than the pipe material; however, it too had been subjected to considerable thinning, particularly in the areas next to the welds joining the elbow to the pipe (Figure 6).

In addition to the thinning on the inside of the pipe, the outside of the pipe had been thinned where the pipe was inserted into the elbow. Although the corrosion at these locations may have been influenced by metallurgical changes in the material caused by the heat of welding, the major factor affecting the corrosion at these locations was most likely turbulence induced by the disruption in flow at the pipe-to-elbow joint.

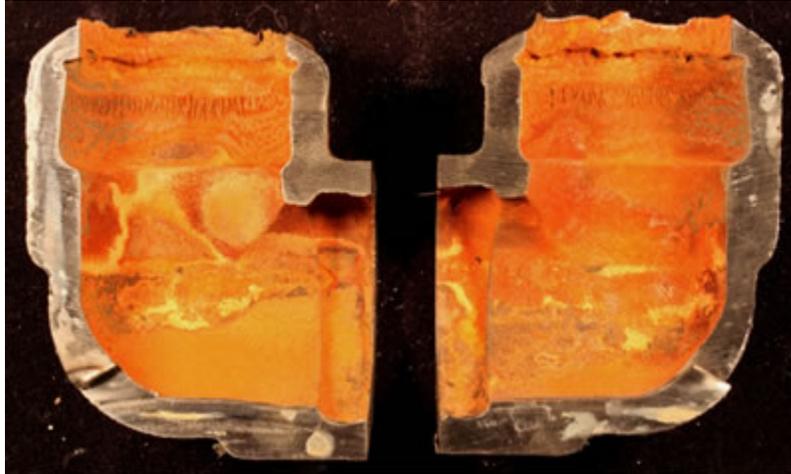
**Figure 7. Longitudinal section thru elbow**

Figures 7 and 8 show a close-up view of the inside of the elbow after sectioning it longitudinally. The jagged edge at the top is the remnants of the pipe, which was only paper thin next to the elbow. The pipe wall had been completely consumed by corrosion in the area where it was inserted into the elbow, and the underlying elbow wall had also been thinned. The corrosion in the elbow consisted of a localized circumferential groove and pit-like depressions, caused by flow/turbulence-induced breakdown of the protective iron sulfate film, and sharp, crack-like, longitudinal grooves, likely caused by hydrogen-grooving.

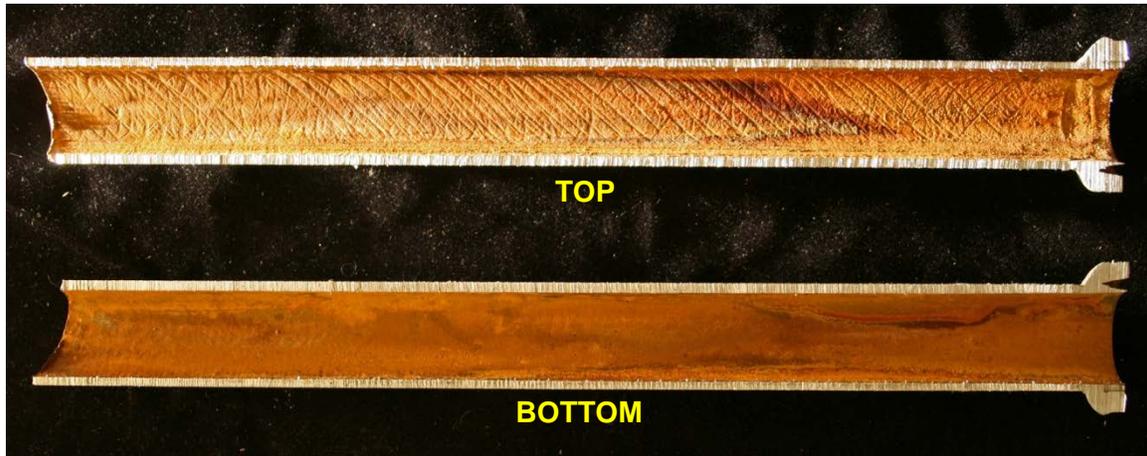
**Figure 9. Longitudinal section thru pipe downstream from elbow**

Figure 9 shows the inside of the pipe downstream of the elbow after sectioning the pipe longitudinally. The top half of the pipe exhibited a series of curved (helical) grooves, indicative of hydrogen grooving. These grooves are shown at higher magnification in Figures 10 and 11, both before and after cleaning to remove the surface corrosion products.

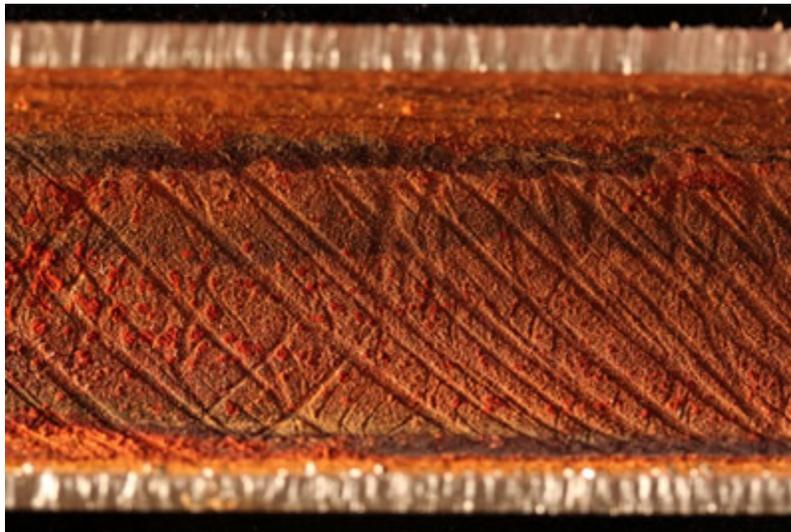
**Figure 10. Close-up view of pipe internal surface before cleaning**

The curved grooves are indicative of hydrogen grooving, a corrosion mechanism that occurs in carbon steel pipe in concentrated sulfuric acid service under conditions of intermittent flow. The grooves are caused by the scrubbing action of hydrogen gas bubbles, which form as a reaction byproduct between the acid and the steel and accumulate on the inside surface of the pipe during periods of non-flow. When flow resumes, the bubbles are carried downstream, scrubbing off the fragile, protective iron sulfate film that forms on the surface of the steel and protects it from further corrosion. The underlying steel then re-corrodes, forming a new layer of iron sulfate. Continued repetition of this action results in a series of grooves in the steel.

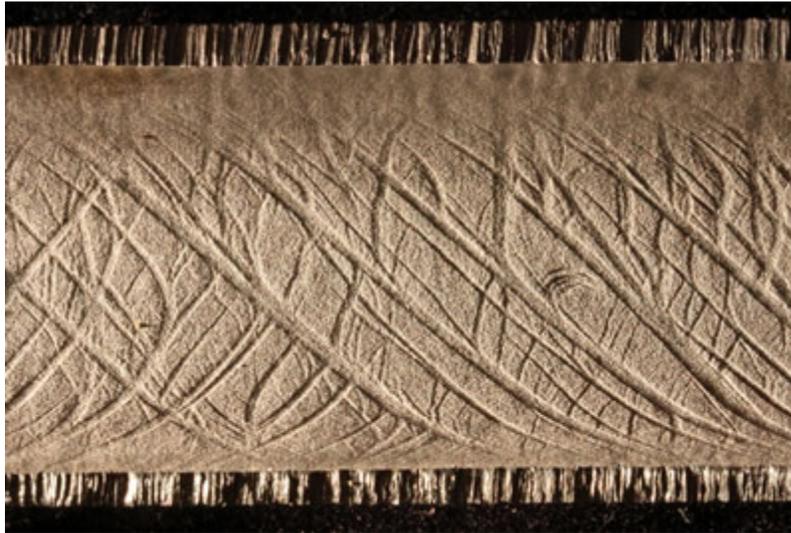
**Figure 11. Close-up view of pipe internal surface after cleaning**

In horizontal sections of pipe, the classical pattern of hydrogen grooving is a series of symmetrical, curved grooves in the two upper quadrants of the pipe, all radiating toward a central longitudinal groove at the very top. In the case of this failure, the pattern was somewhat different, consisting of a series of helical—and at some locations, criss-crossed—grooves, without the central longitudinal groove. The pattern was probably the result of a spiral flow pattern in the pipe, induced by the change in flow direction at the elbows.

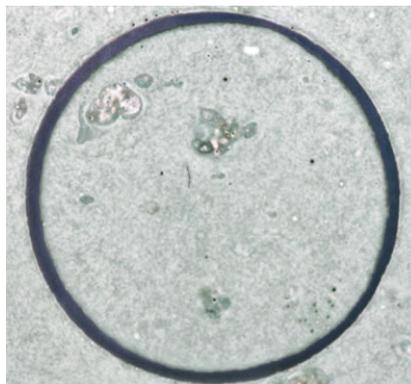
**Figure 12. Transverse cross section thru pipe 2 inches upstream from leak**

The microstructure of the pipe material was examined in a transverse cross section through the pipe approximately 2 inches upstream from the leak (Figure 12). Although the pipe was slightly thicker at this location than it was at the leak, the pipe wall was still severely thinned, ranging in thickness from 0.020 to 0.050 inch. Further away from the hole, the pipe wall was somewhat thicker, with minimum wall thicknesses generally in the range of 0.060 to 0.080 inch; however, based on its original thickness of 0.133 inch, the thinning in these areas was still about 50 percent of the way through the wall.

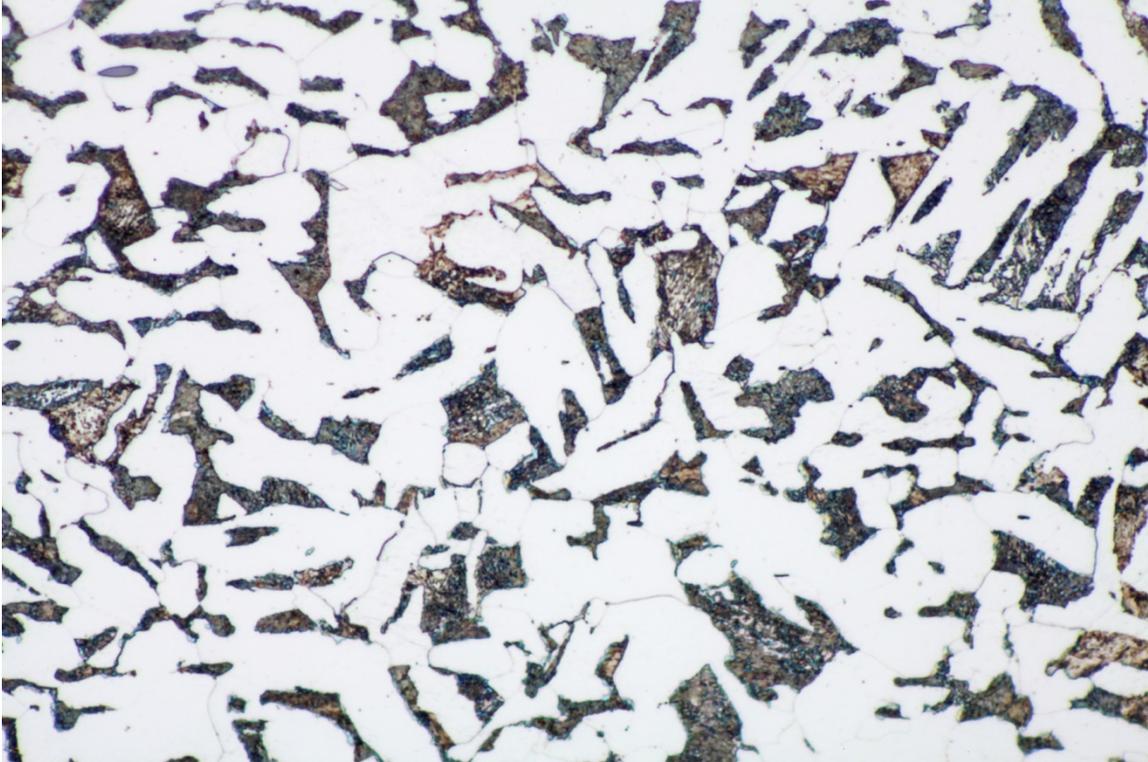
**Figure 13. Ferrite (light constituent) and pearlite (dark constituent) pipe microstructure**  
1,000X Etchant: Nital

The microstructure was comprised of ferrite and pearlite, which is the expected microstructure for carbon steel pipe in this application (Figure 13). Microhardness of the pipe ranged from 79 to 89 on the Rockwell B scale (HRB), which is within the expected range for piping in this application. No metallurgical defects or other material-related flaws were observed that would be considered contributory to the failure.
